LANDSLIDES AND RELATED FEATURES

OF THE FRANKSTOWN, PA. QUADRANGLE

by  
John S. Pomeroy  
1979

OPEN FILE MAP 79-1314 (D-14)

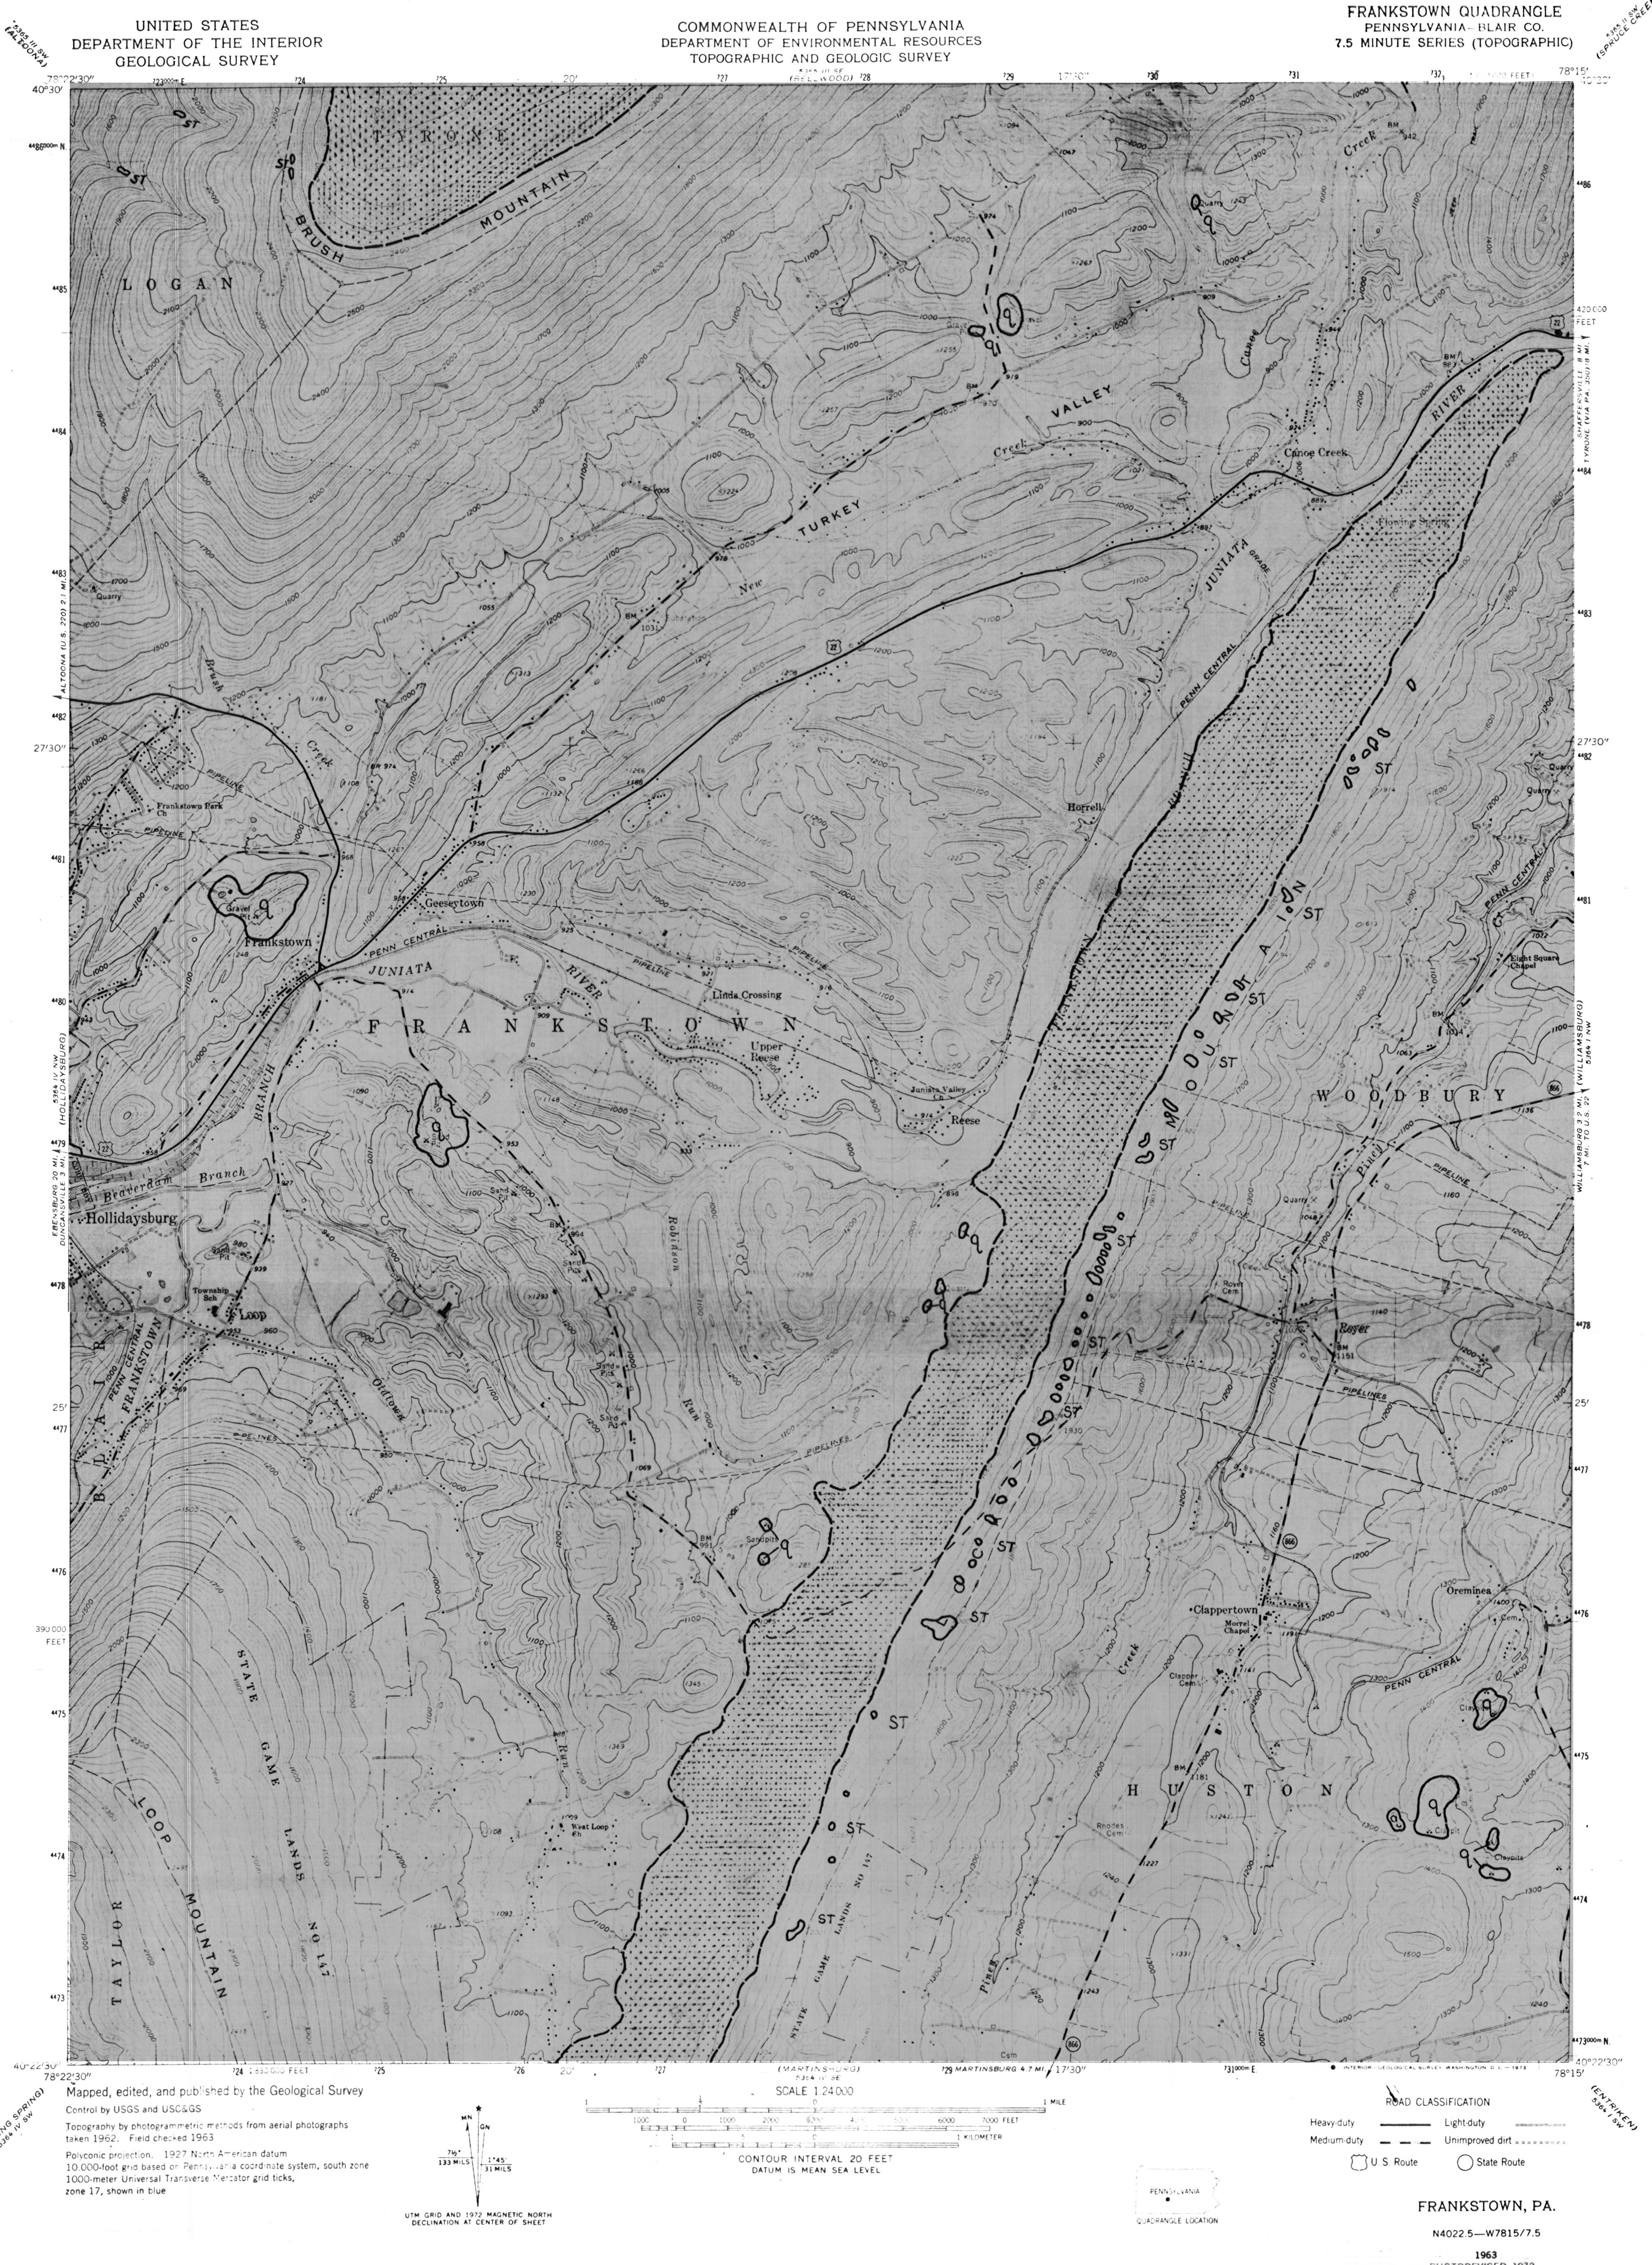
Landslides and related features interpreted from aerial photographs: 1:78,000 (black and white) 1977

Photointerpretation and field check 1977  
This map has not been edited or reviewed for conformity with Geological Survey standards and nomenclature.

Complex landslide composed of earthflow, debris slide, earth and rock slump. Identified from historical records, and from scars, debris and other field evidence. Ground extremely unstable; sliding accelerated by excavation, loading and changes in drainage conditions. May include areas with several active slides too small to be shown separately. Questioned where doubtful.

Area of extensive hummocky ground caused by earthflow and earth and rock slump. Lacks clear evidence of active sliding. Relatively stable in natural, undisturbed state, generally not affected by small structures properly sited in areas away from the edge of the toe; can be reactivated by extensive, rapid excavation, loading, and changes in ground water and surface water conditions. Area of old landslide probably includes recent ones not identified from field evidence or otherwise documented. Upslope boundary of landslide generally defined by modified scarp, but downslope (toe) may be gradational and not well defined. Questioned where doubtful.

Area of recent and old slides in which individual slides are not identified.

Valley wall along major streams with slope as steep as 40° (85%); stony, clayey silt, soil up to 50 ft. (15 m) thick; commonly buttressed by a terrace or bench at the toe of the slope; very susceptible to sliding by cutting of toe area, removal of terrace or bench, and overloading; slide commonly activated without apparent cause.

Residual accumulations of coarse rock material lying on quartzite slopes of the Valley and Ridge province. Generally stable except where subjected to extreme rainfall.

Landslides too small or obscure to map individually.

Primarily shallow, narrow ravines and chutes with accumulation of stony colluvium generally 10 ft. (3 m) or less in thickness; susceptible to rapid movement during intense rainfall. Most ravines and chutes designated show evidence of former debris flows and avalanches. Symbol & designates historical debris flow or debris avalanche.

Steep, locally vertical, natural and man-made slopes and cliffs, 15 ft. (4.5 m) or more high; formed dominantly of sandstone, limestone, sandy shale, mudstone and claystone. Interbedded mudstone, claystone and shale weather rapidly leaving sandstone and limestone rock faces unsupported.

Soil and rock similar to that involved in landslides elsewhere in map area; primarily areas underlain by claystone, mudstone and shale associated with other rock types. Rock weathers rapidly on exposure forming clayey soil highly susceptible to sliding. Includes chutes (U-shaped, shallow valleys) containing thick layers of clayey soil that are very susceptible to sliding where excavation breaks continuity of slope and where overloaded by artificial fill.

Map areas in which no patterns or symbols are shown; primarily valley floors, ridge tops and broad benches; modification by excavation and fill may lead to local landslides. Includes slopes where landslides are sparse.
